WL-TR-97-2053

THIN DENSE CHROME BEARING INSERTION  
PROGRAM

GE AIRCRAFT ENGINES  
ADVANCED ENGINEERING PROGRAMS DEPT  
ONE NEUMANN WAY  
CINCINNATI OH 45215-6301

FINAL REPORT FOR 03/01/92-12/01/96

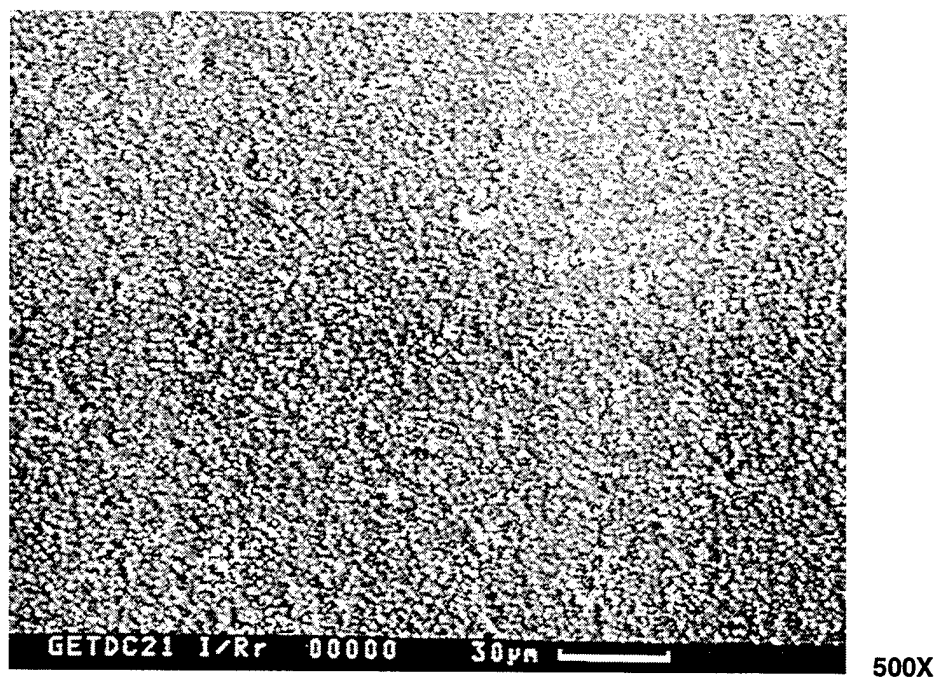
Figures 3 through 10 show the TDC topography of the raceway and shoulder in four different locations around the bearing using the scanning electron microscope (SEM) at 500X. The coating exhibits a nodular TDC without any evidence of cracking. Although this topography passed the GE specification, some variation in nodule size is evident in these micrographs.

Figure 3. SEM Quality/Topography Photo of Position 1 (0°) in Raceway. *Within spec.*

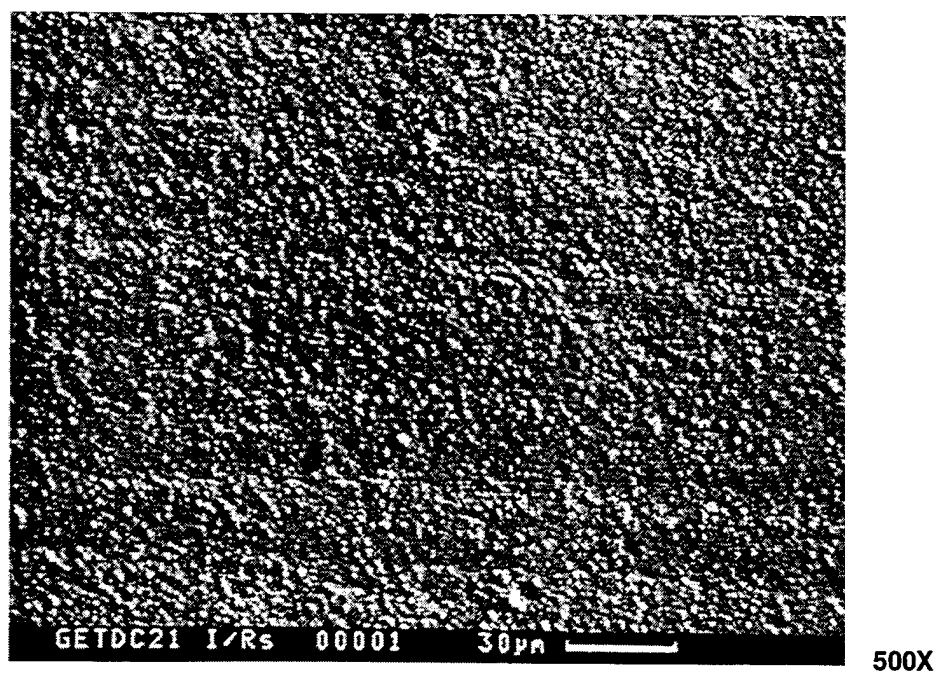
Figure 4. SEM Quality/Topography Photo of Position 1 (0°) in Shoulder. *Within spec.*

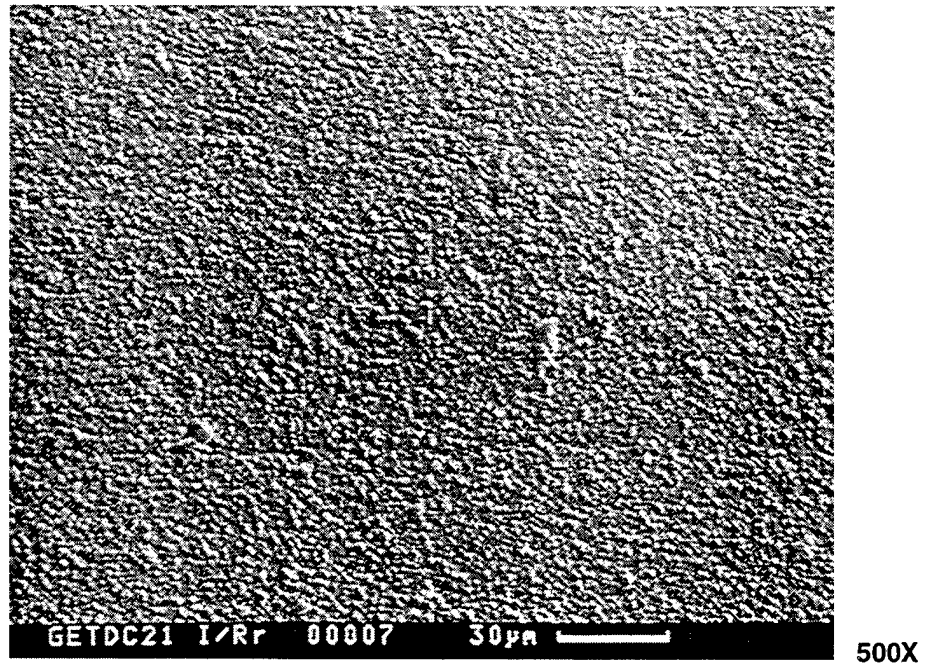
Figure 5. SEM Quality/Topography Photo of Position 2 (90°) in Raceway. *Within spec.*

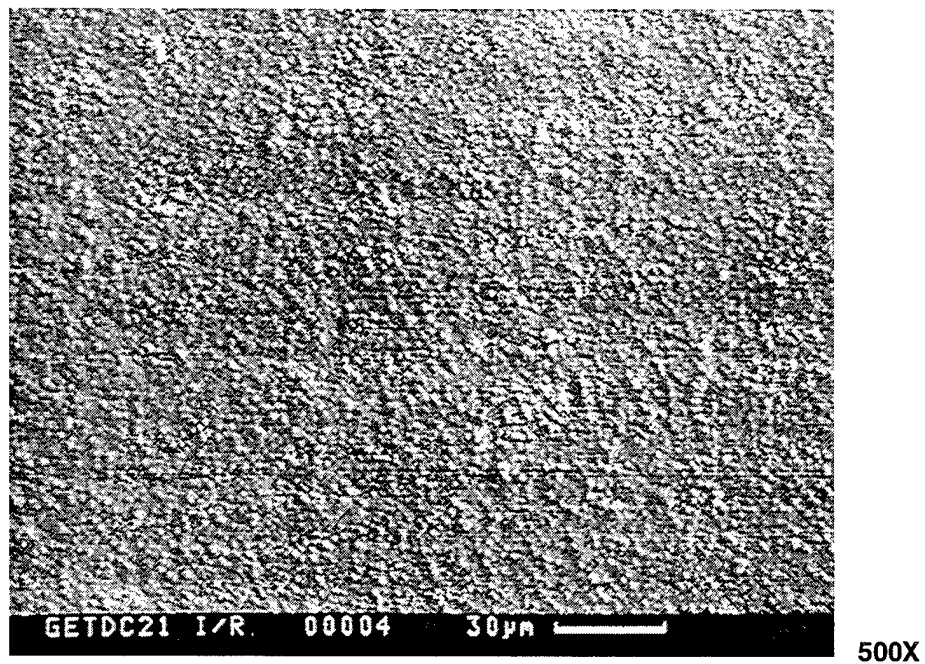
Figure 6. SEM Quality/Topography Photo of Position 2 (90°) in Shoulder. *Within spec.*

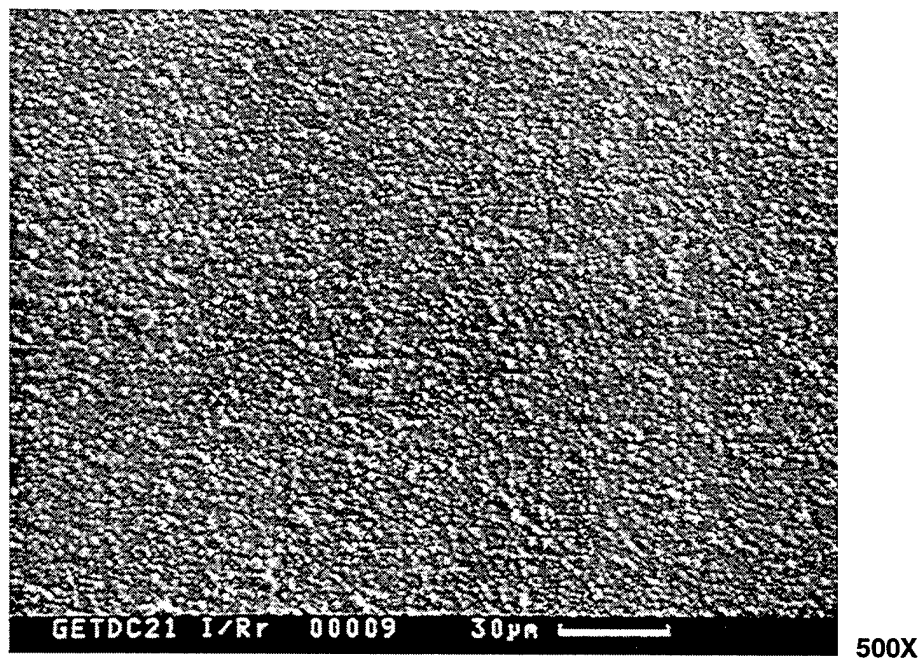
**Figure 7. SEM Quality/Topography Photo of Position 3 (180°) in Raceway. *Within spec.***

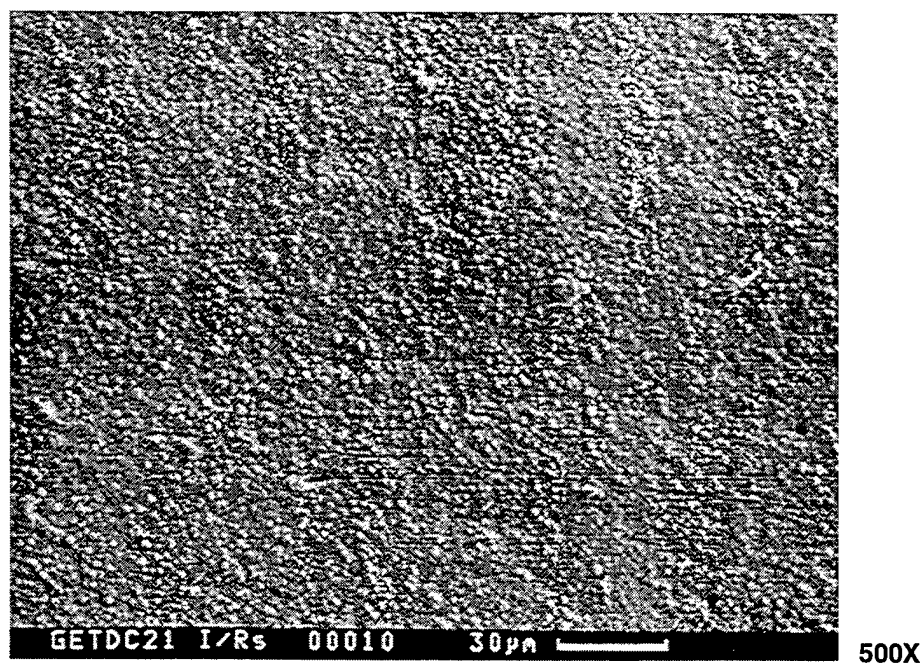
**Figure 8. SEM Quality/Topography Photo of Position 3 (180°) in Shoulder. *Within spec.***

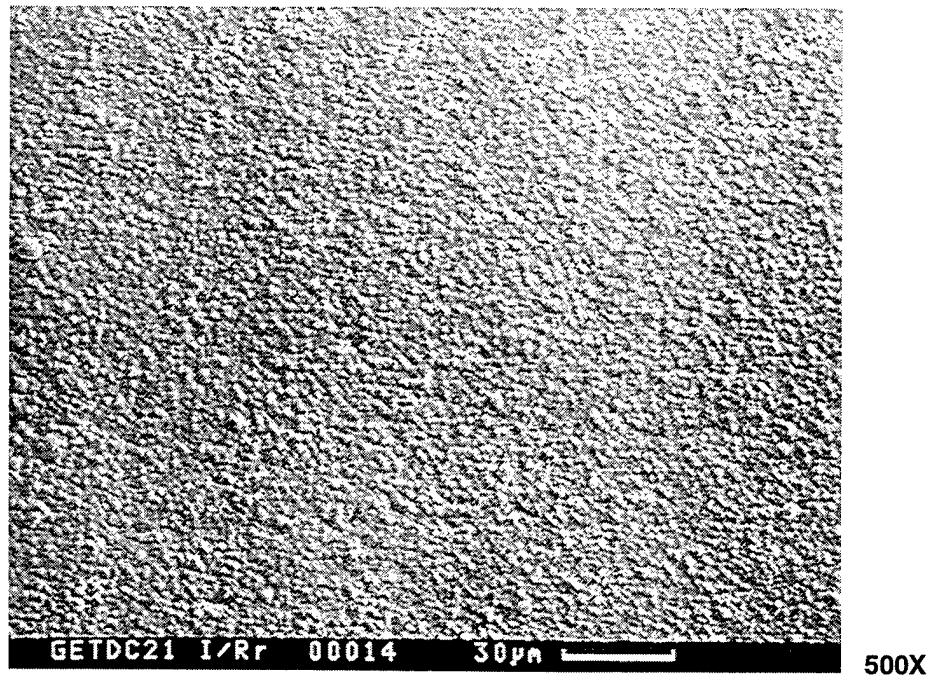
Figure 9. SEM Quality/Topography Photo of Position 4 (270°) in Raceway. *Within spec.*

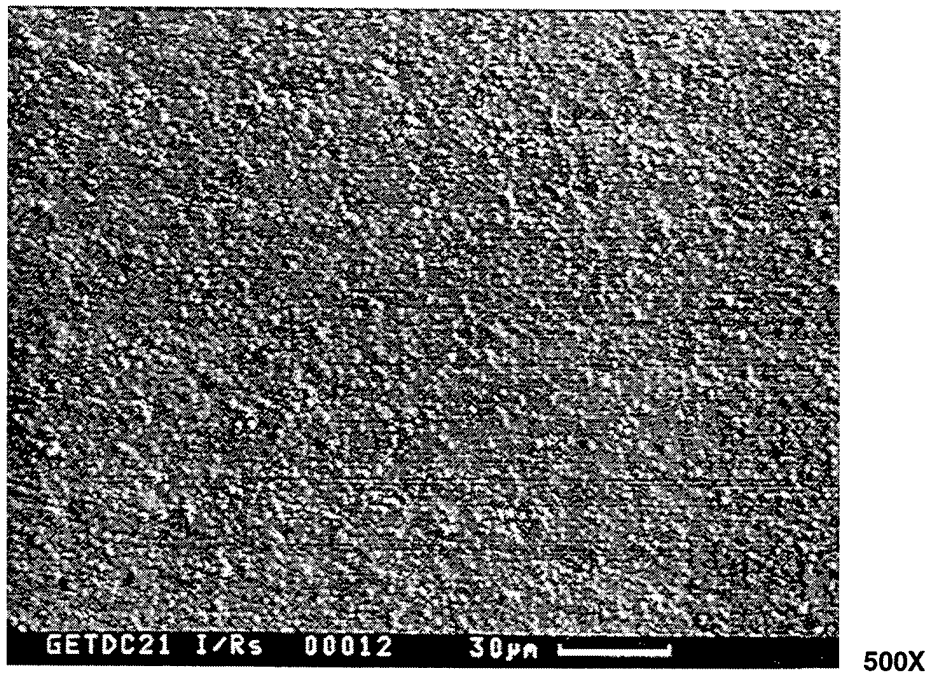
Figure 10. SEM Quality/Topography Photo of Position 4 (270°) in Shoulder. *Within spec.*

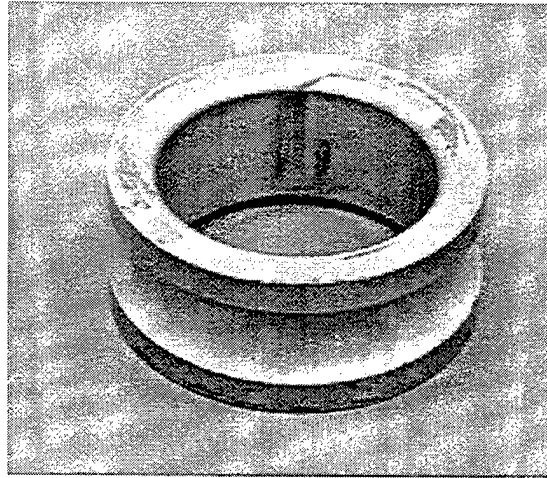
The tested bearing is shown in Figure 11. The staining which is evident on the bearing came from stamp marks, vibration peen marks, and

**Figure 11. Photo of Inner Ring from 24-Hour Salt Spray Test (MRC Round 1).**  
*Although the ball track was free of corrosion, a few isolated areas did corrode resulting in the staining evident in the photo.*

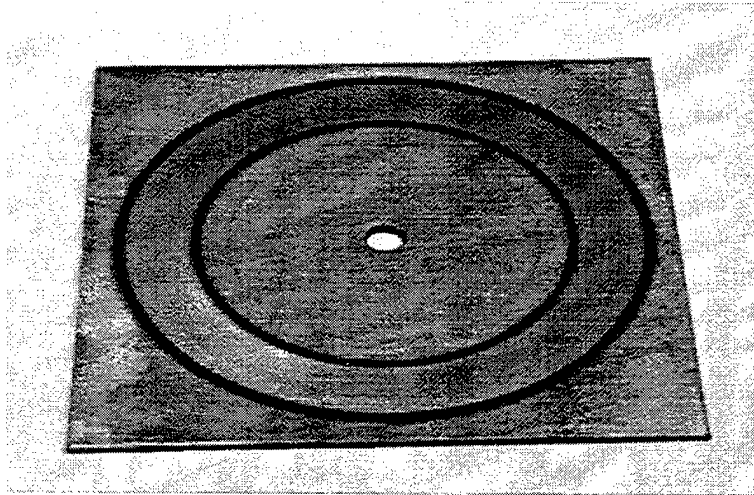
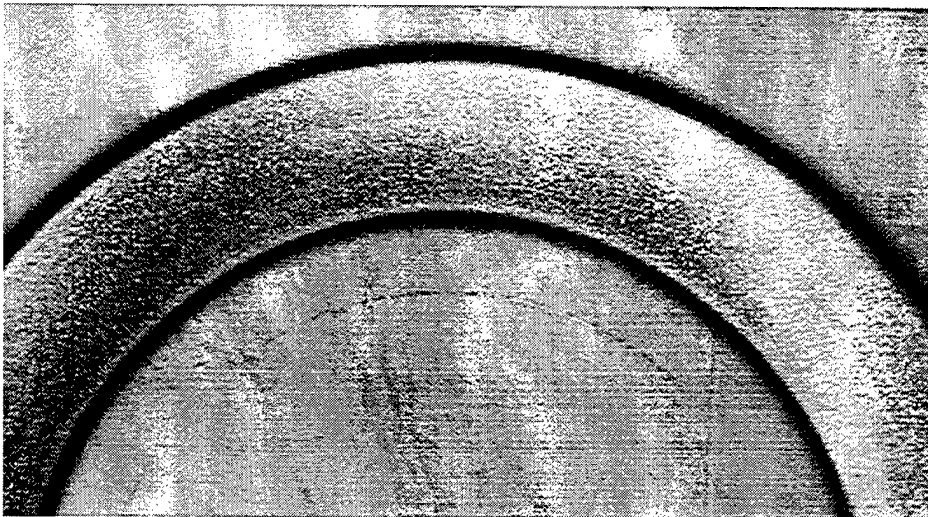
Taber wear data indicates a wear index of 0.2 (an average of 1.0 milligram weight loss) for the three specimens tested. This is considerably less than the requirement of a wear index 1.2 or less. **Figure 13** shows a typical posttest specimen. The test machine used was at Bridgeport Testing Laboratory. The test certification is included in Appendix A.

**Figure 13. Photos of Taber Wear Test Specimen.**  
*Specimen wear of 0.2 was well below the upper wear index limit of 1.2.*

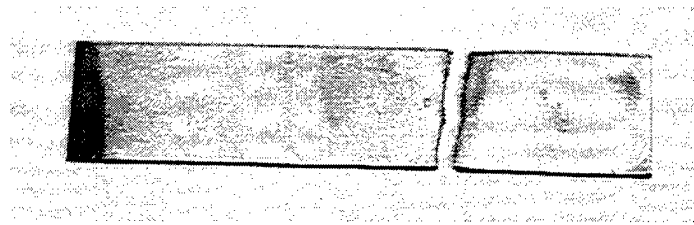
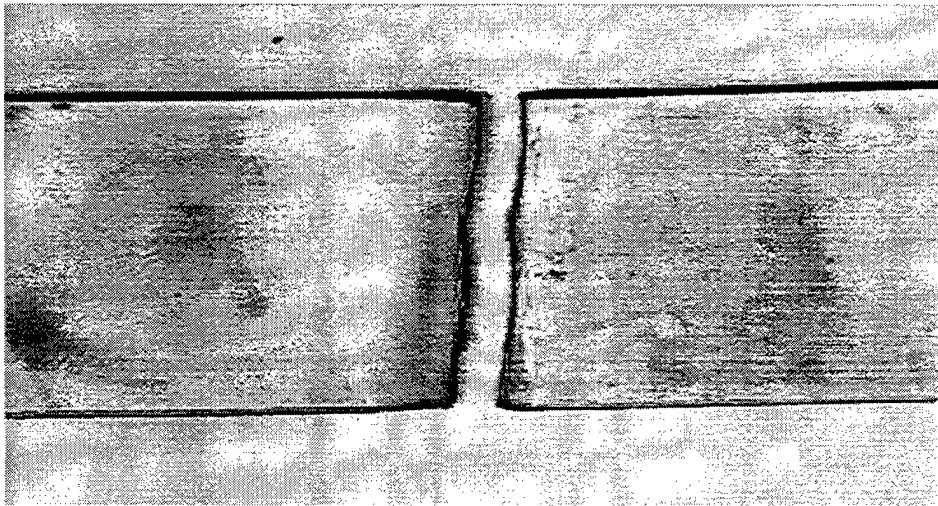
**Figure 14** shows the panel used in the bend test performed by Armoloy of Connecticut. Post-bend test inspection indicated that the TDC coating adhered to the base metal, and did not flake, peel, or delaminate.

**Figure 14. Photos of Bend Test Specimen.**  
*TDC did not flake, peel, or delaminate.*

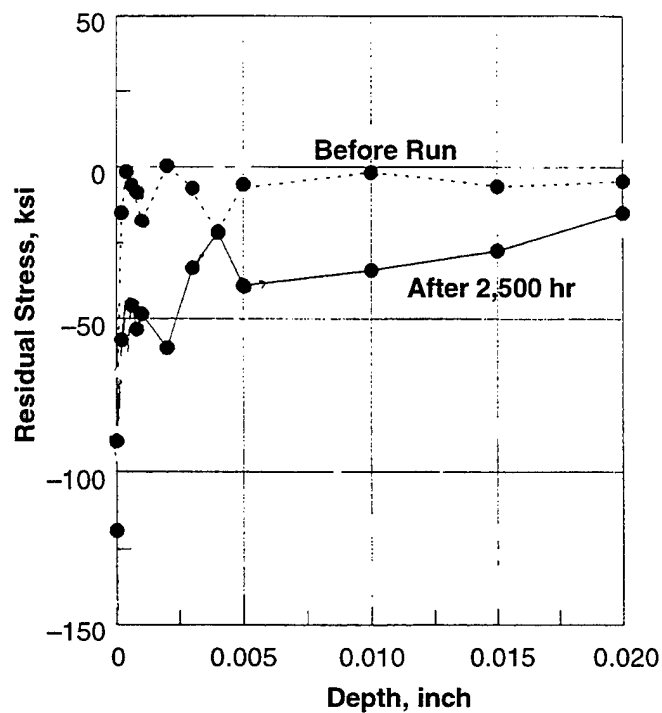
Residual stress profiles of plain and TDC coated bearing inner rings after 2,500 hours of endurance testing, as shown in **Figures 37** and **38** indicated both a large residual compressive stress in the area of the 0.010in deep for the TDC coated and a smaller and shallower ( $\approx 0.005$ in deep) subsurface compressive stress for the plain bearing. Since the depth of maximum shear stress is proportional to the contact area which in turn is proportional to the applied load and inversely proportional to the modulus of elasticity, it was concluded that the TDC bearing was either operating at a higher load, at a higher contact temperature, or both.

**Figure 37. Residual Stress Profiles of MRC Round 1 Bare Baseline Rings.** *Note the degree of change between the before and after the 2,500 hours is small when compared to the profile of the TDC coated bearings shown in Figure 38.*

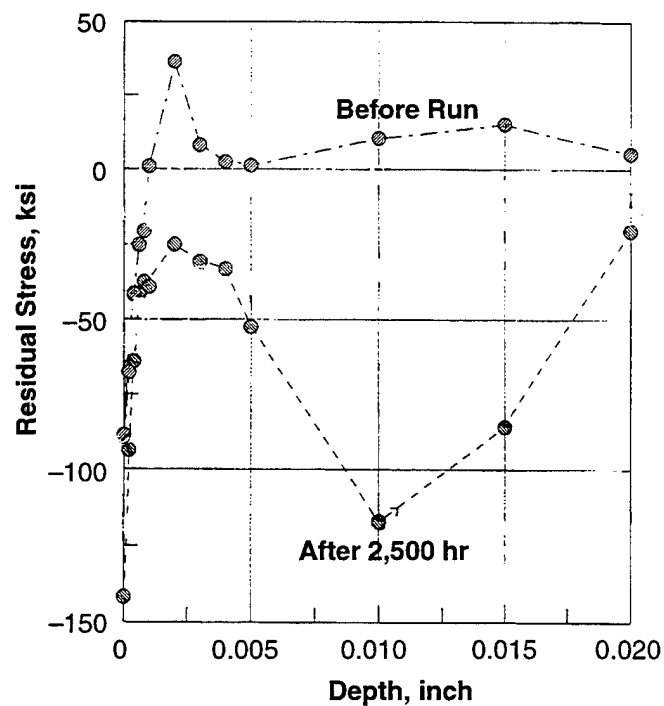
**Figure 38. Residual Stress Profiles of MRC Round 1 TDC Coated Rings.** *Note the Large compressive stress at 0.010 inch deep as a result of the 2,500 hours of operation.*

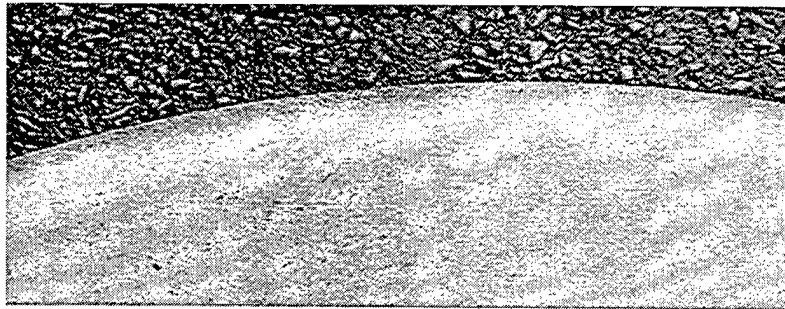
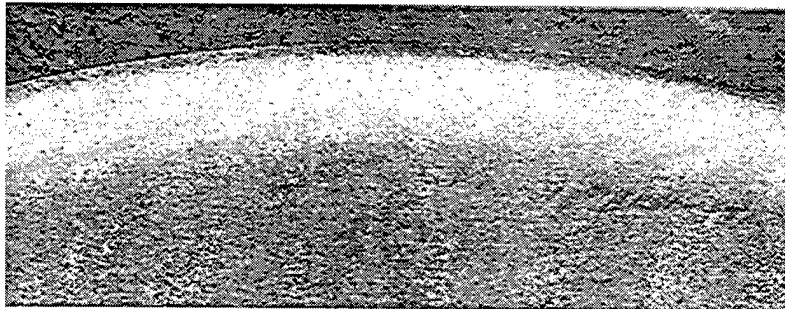
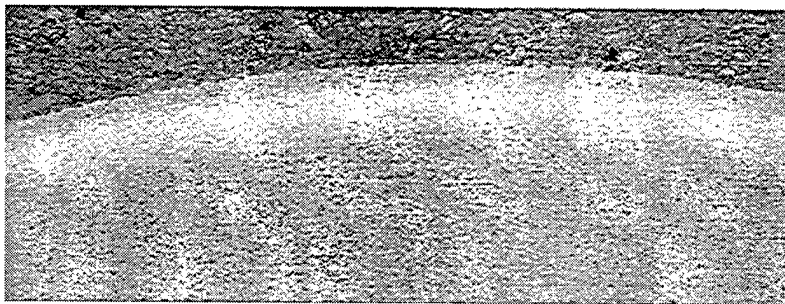
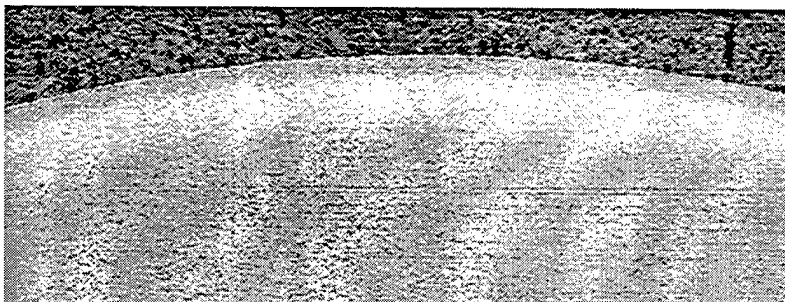
An examination of the M50 balls from both the TDC plated bearings and the plain bearings revealed a larger amount of stress induced microstructural alterations (white etching microstructure) at the maximum shear depth in the TDC plated bearings than in the plain bearings. This is further evidence that the TDC bearings were operating at a higher load, higher temperature, or both. **Figure 46** shows the

**Figure 46. Optical Micrograph of MRC Round 1 TDC Test Balls.**  
*Note white etching layer in max. shear zone.*

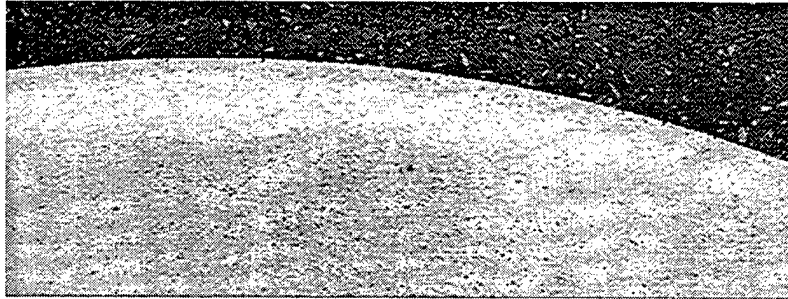
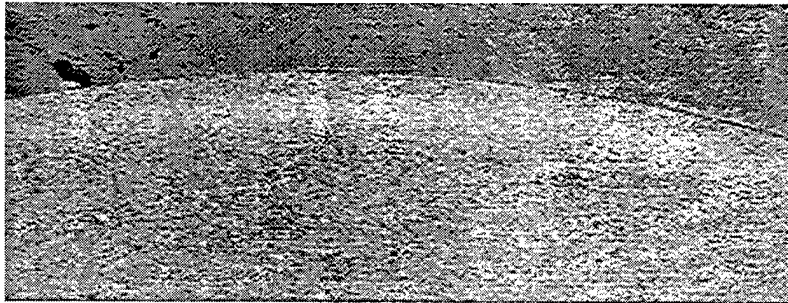
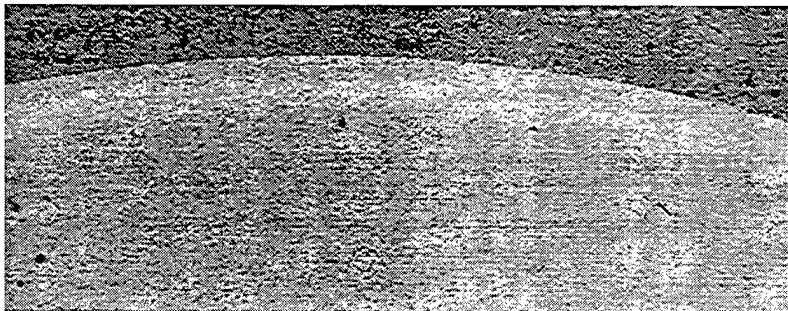
**Figure 47. Optical Micrograph of MRC Round 1 Plain Test Balls.**  
*Note lesser amount of white etching layer compared to balls from coated bearing balls, Figure 46.*

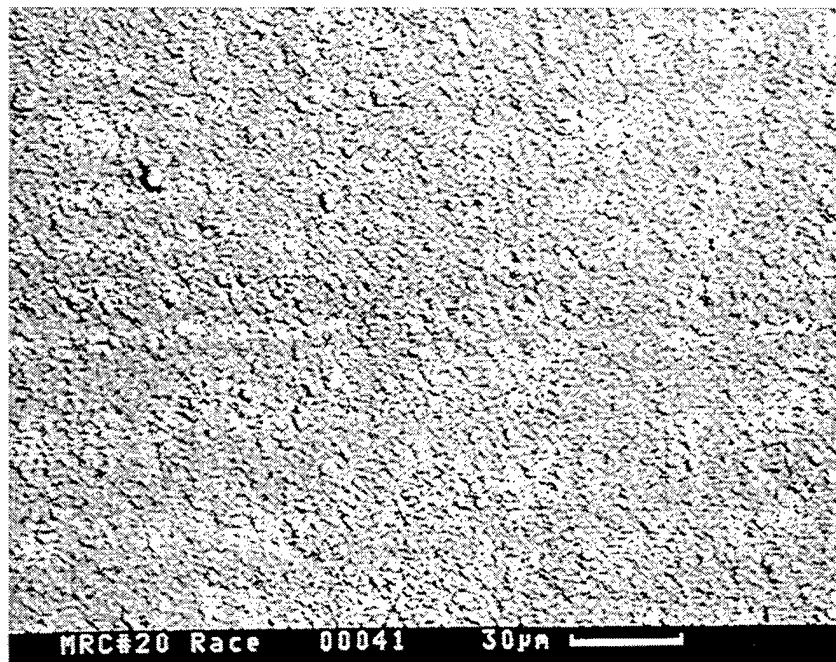
Scanning Electron Microscope inspection of an inner ring GE TDC 20 (**Figures 48 through 51**) indicated that the TDC coating lacked the typical well rounded nodules in the ball track and

**Figure 49. SEM Photo of Bearing Raceway, BEI Mode.** *Note lack of typical TDC nodularity.*

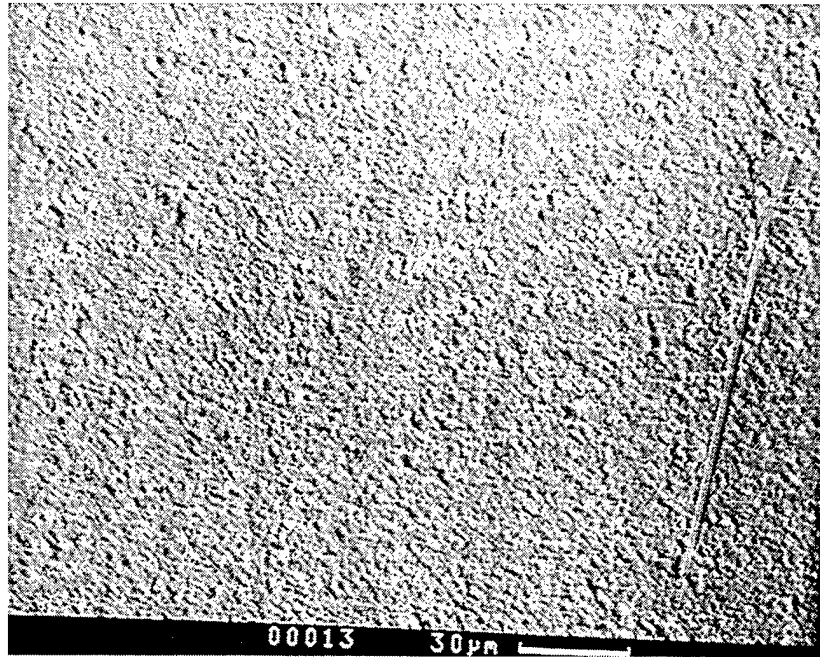
Prior to testing, inner ring GE TDC 31 was evaluated on the SEM to determine if it contained cracks as was seen in S/N 20. **Figures 52 through 61** show the topography of this bearing. Cracks were evident at the edge of the raceway track and the edge of the land. Upon completion of the 24-hour salt spray testing, numerous rust spots appeared on this specimen (**Figure 62**) and it was deemed to have failed this test. This result was also confirmed with inner race GE TDC 18. It contained a similar amount of corrosion after a salt spray test. The amount of corrosion in Round 2 was considerably greater than that exhibited in Round 1. Test results are in Appendix B.

**Figure 52. SEM Photo of Center of Bearing Raceway, SEI Mode.**  
*Note lack of nodularity.*

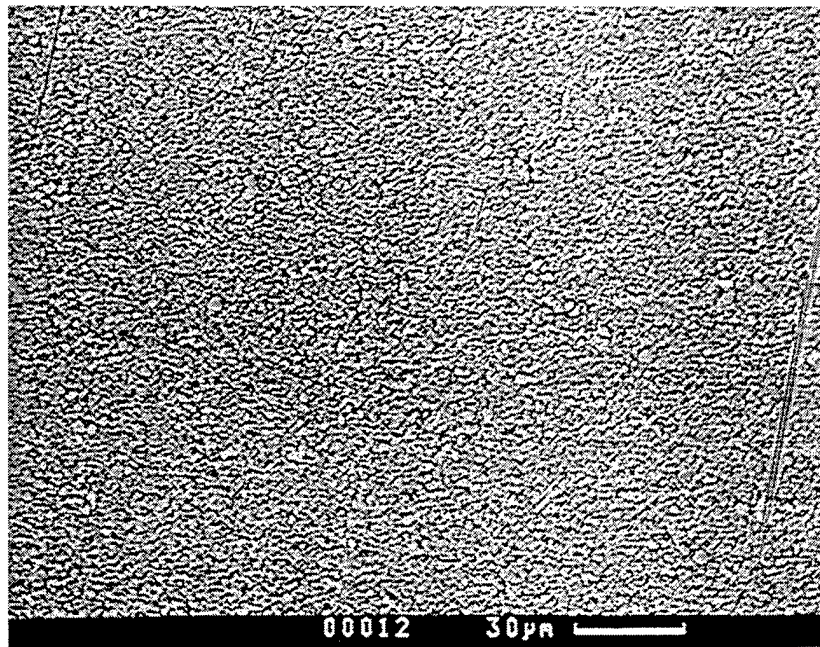
**Figure 53. SEM Photo of Center of Bearing Raceway, BEI Mode.**  
*Coating is intact in this area.*

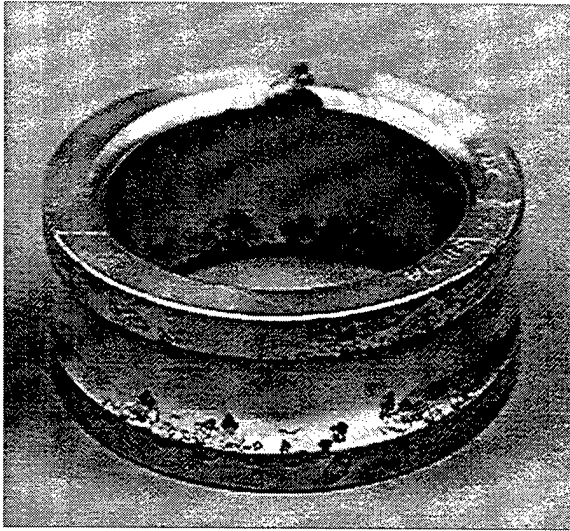
Figure 62. Photo of GE TDC 31 Inner Ring Corrosion after Salt Spray Test. Note large amount of rust.

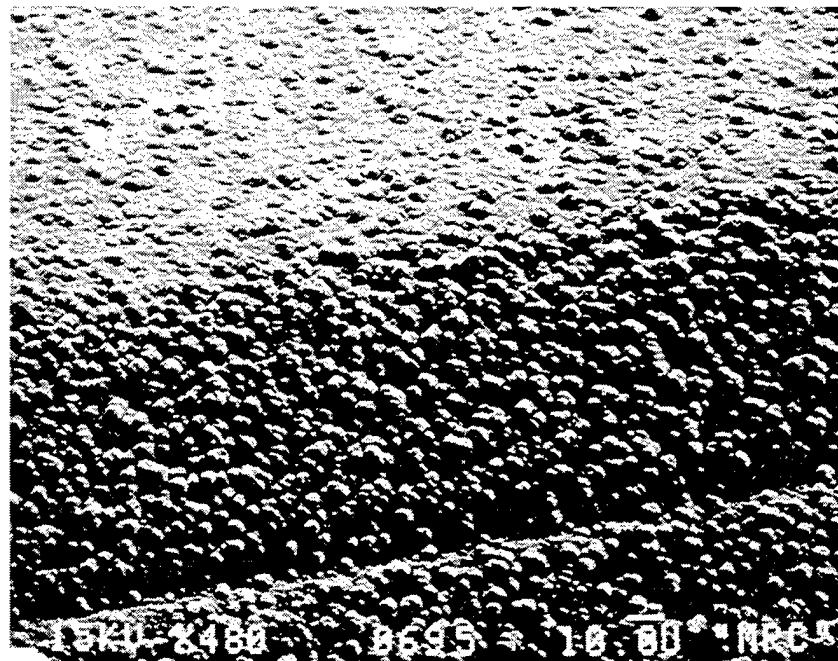
**Figure 64.** SEM Photo of Race/Land Edge, 0°. *Note mix of nodularity, both flat and nodular areas exist in the race/land edge.*

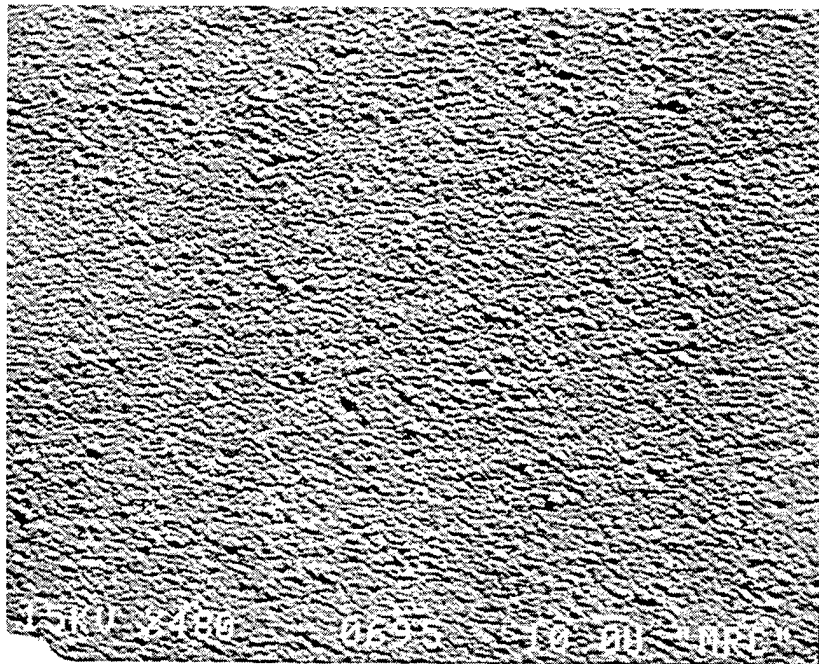
**Figure 65.** SEM Photo of Raceway, 90°. *Note lack of nodularity.*

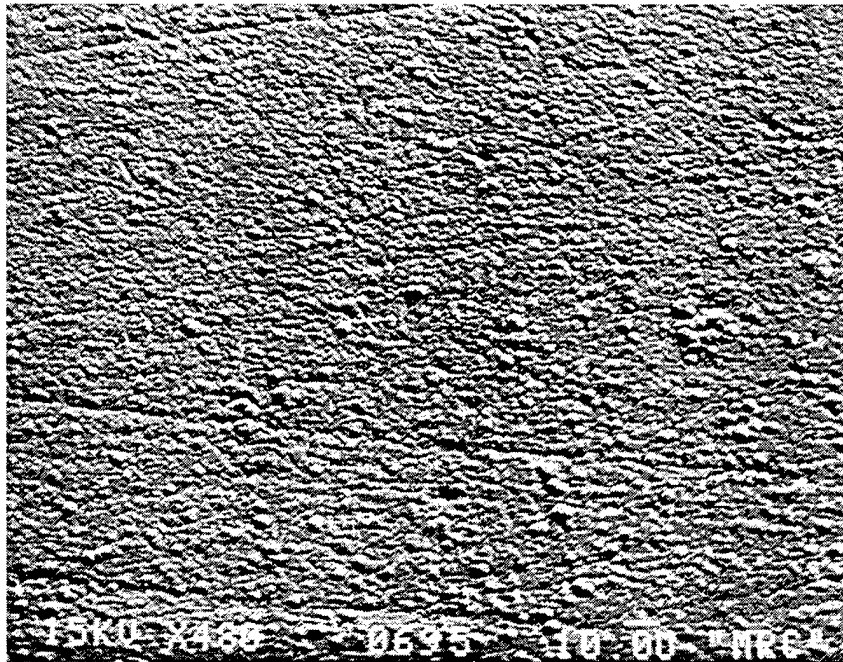
**Figure 67.** SEM Photo of Raceway, 180°. *Note lack of nodularity.*

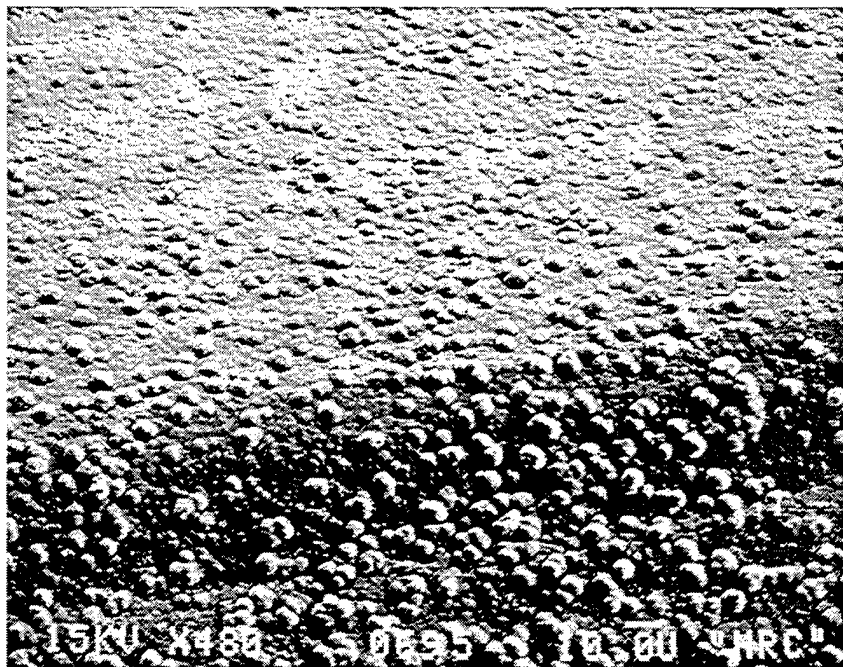
**Figure 68.** SEM Photo of Raceway, 180°. *Note chrome nodules on top of a relatively flat surface.*

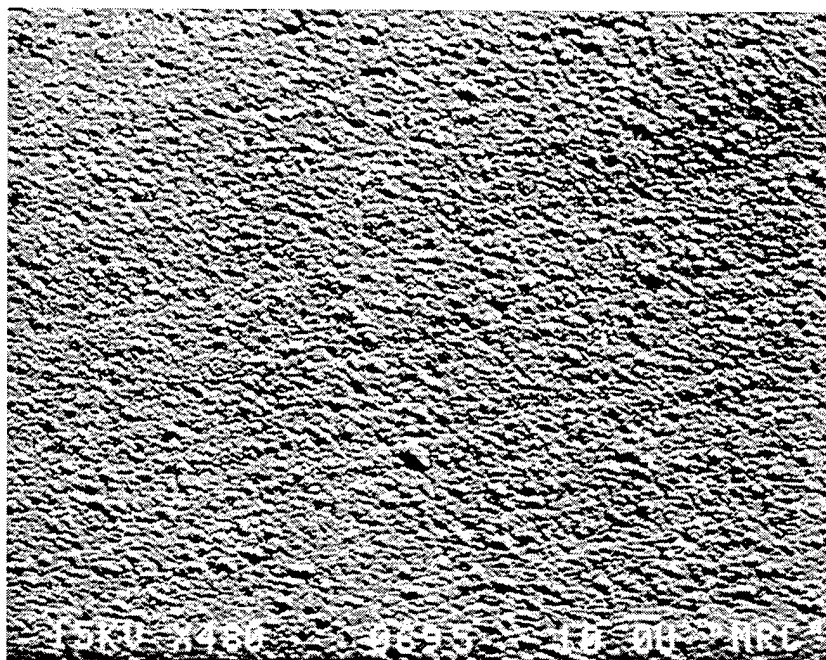
**Figure 69.** SEM Photo of Raceway, 270°. *Note lack of nodularity.*

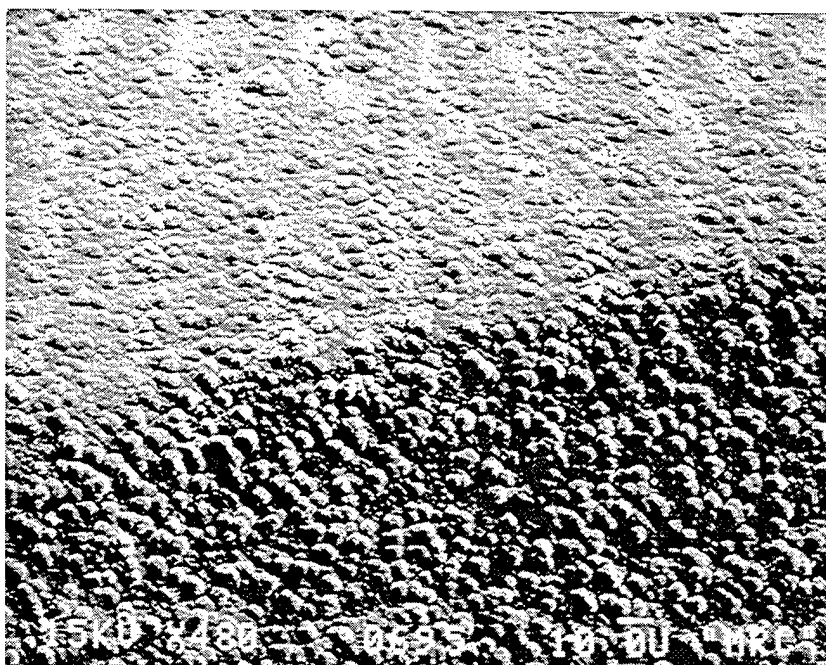
**Figure 70.** SEM Photo of Race/Land Edge, 270°. *Note chrome nodules on top of a relatively flat surface.*

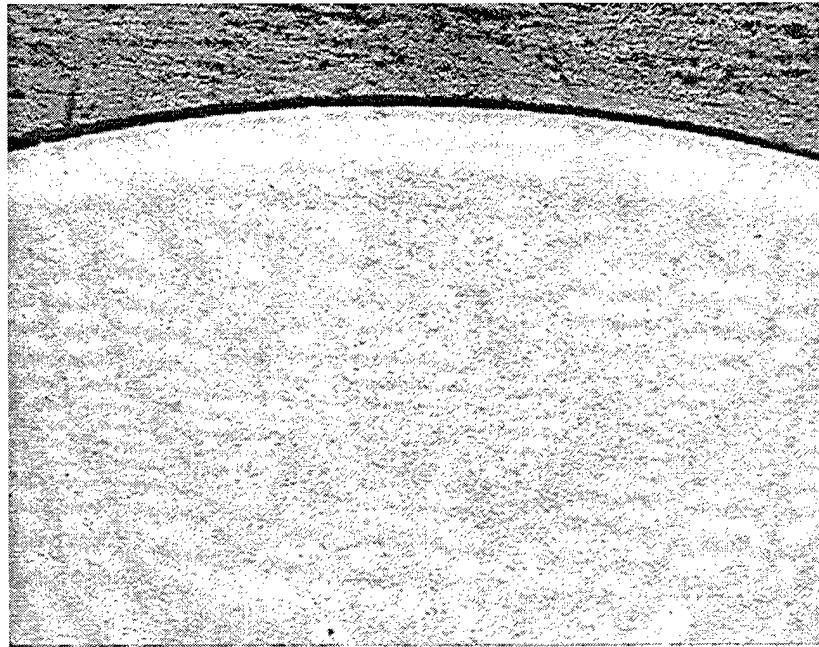
**Figure 74. Subsurface Stress Induced Microstructural Alteration (White Layer) in Ball from Round 2/Test 11.** *The layer covered the entire ball indicating the ball was spinning.*

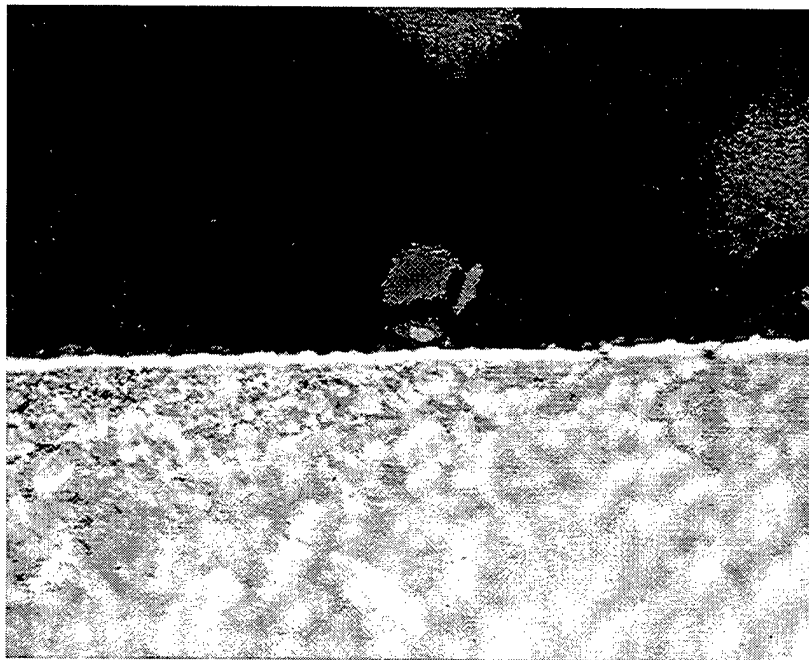
**Figure 75.** Optical Photomicrograph of TDC Layer on Raceway of Inner Ring, 65  $\mu\text{in}$  Thick.  
*Met specification.*

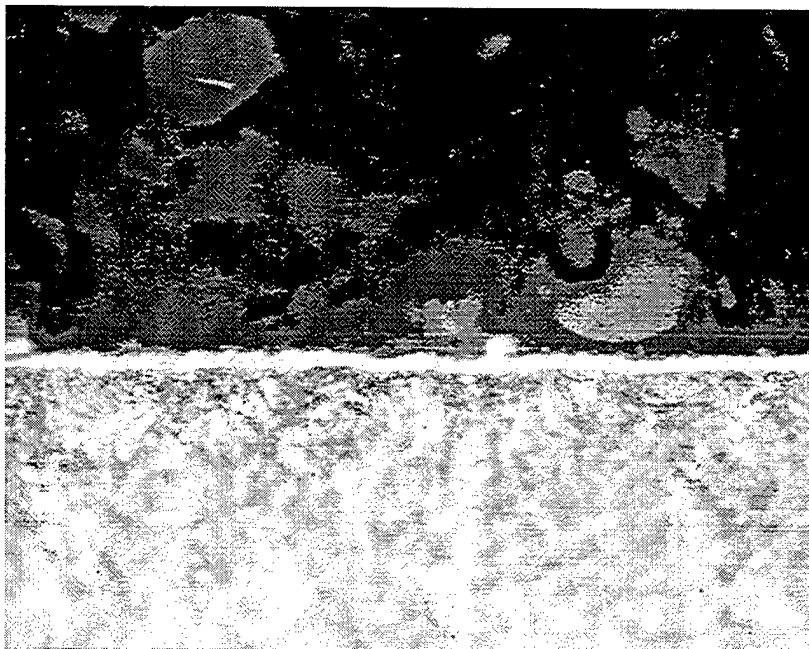
**Figure 76.** Optical Photomicrograph of TDC Layer on Land of Inner Ring, 80  $\mu\text{in}$  Thick.  
*Met specification.*

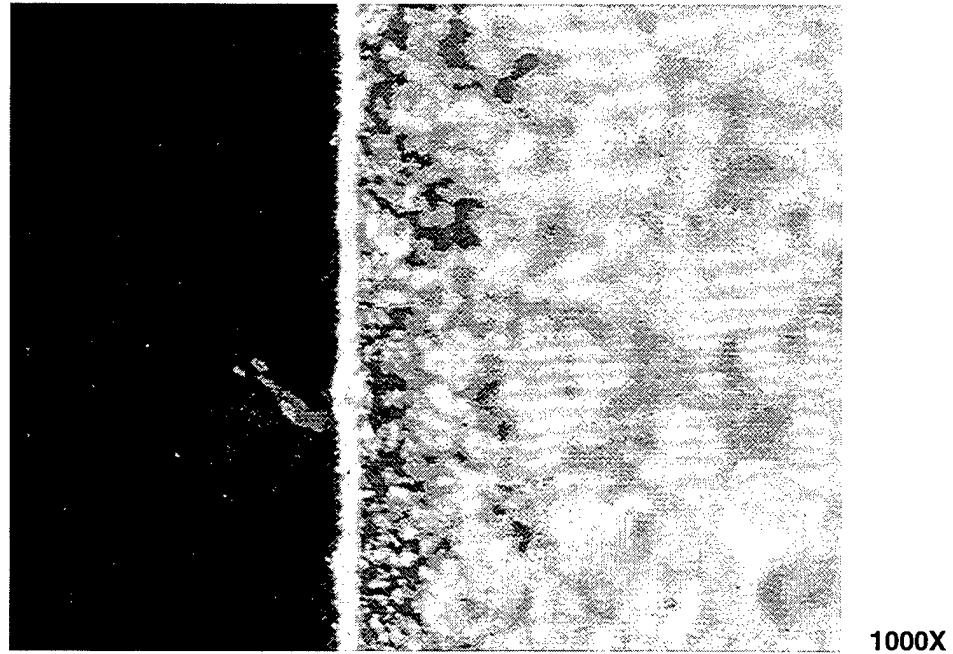
**Figure 77. Optical Photomicrograph of TDC Layer on Face of Inner Ring, 105  $\mu$ m Thick.**  
*Met specification.*

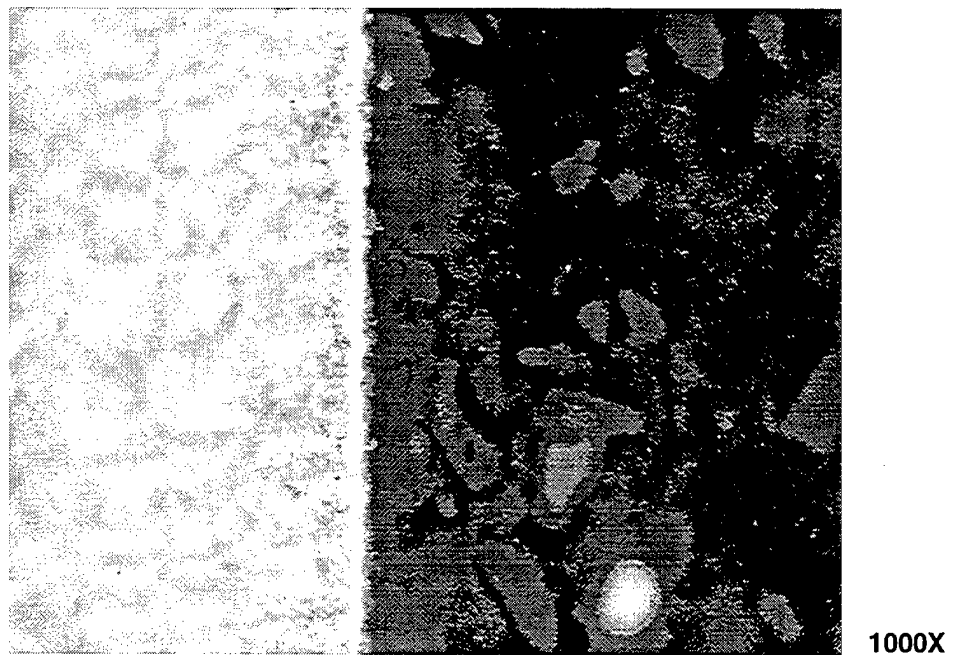
**Figure 78. Optical Photomicrograph of TDC Layer on Face of Inner Ring, 95  $\mu$ m Thick.**  
*Met specification.*

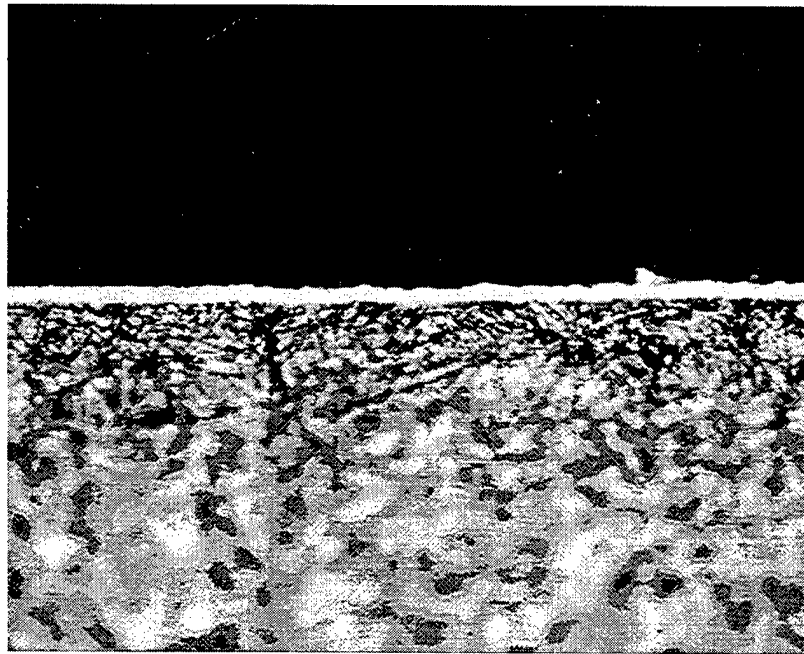
**Figure 79.** Optical Photomicrograph of TDC Layer on Bore of Inner Ring, 90  $\mu\text{m}$  Thick.  
*Met specification.*

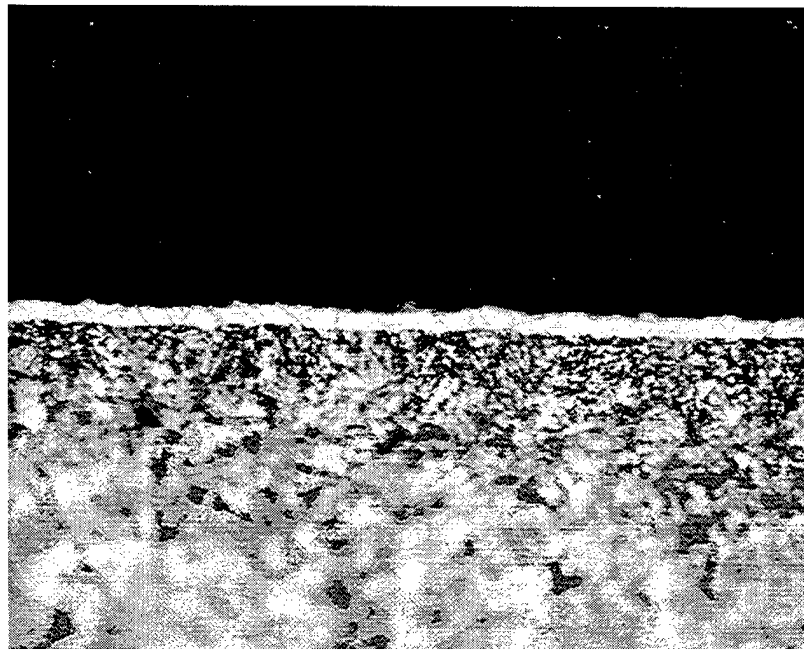
**Figure 80.** Optical Photomicrograph of TDC Layer on Bore of Inner Ring, 100  $\mu\text{m}$  Thick.  
*Met specification.*

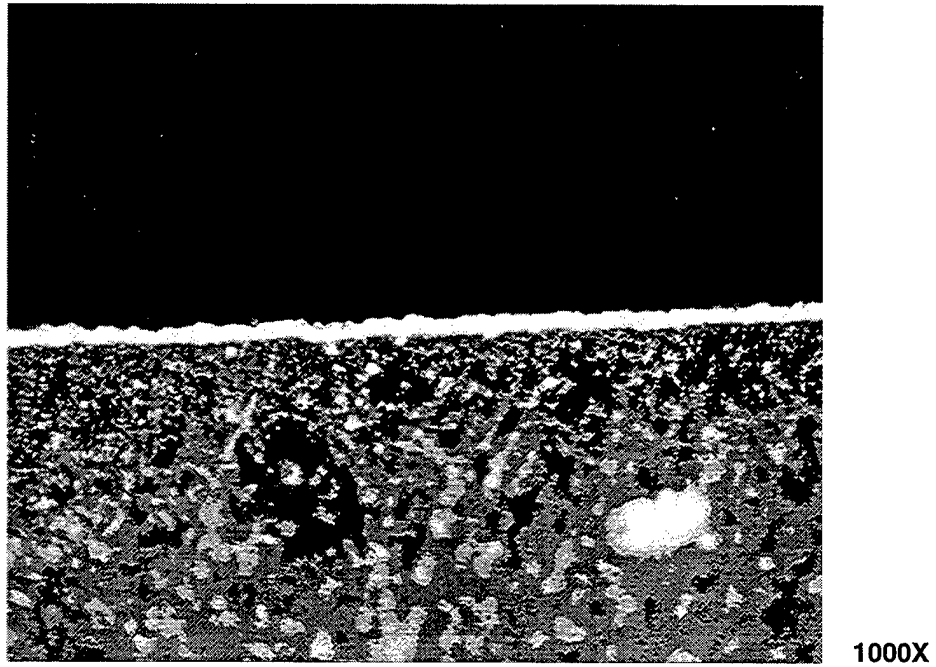
**Figure 81.** Optical Photomicrograph of TDC Layer on Raceway of Outer Ring, 85  $\mu\text{in}$  Thick.  
*Met specification.*

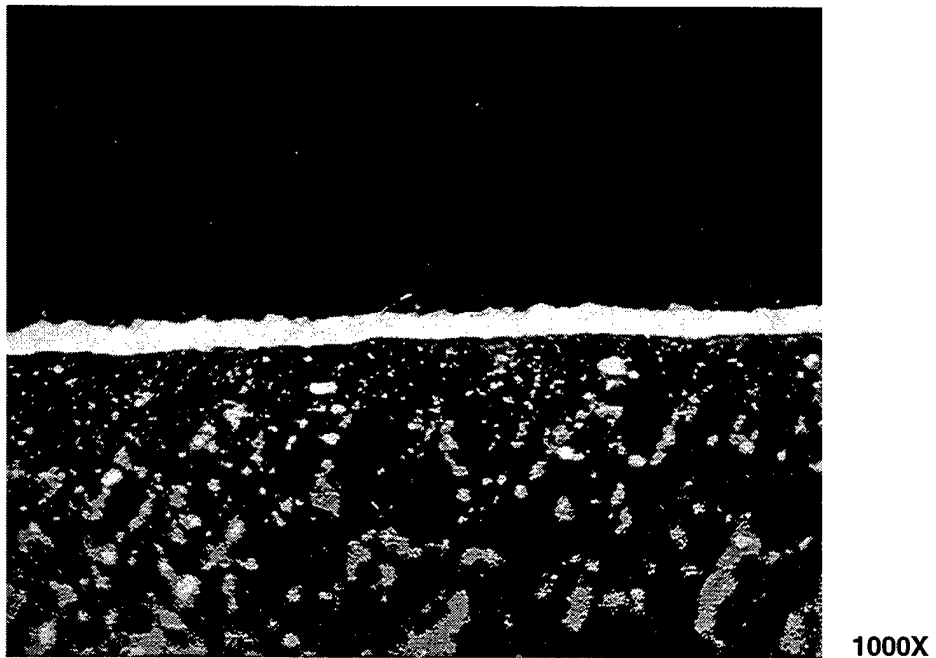
**Figure 82.** Optical Photomicrograph of TDC Layer on Land of Outer Ring, 140  $\mu\text{in}$  Thick.  
*Met specification.*

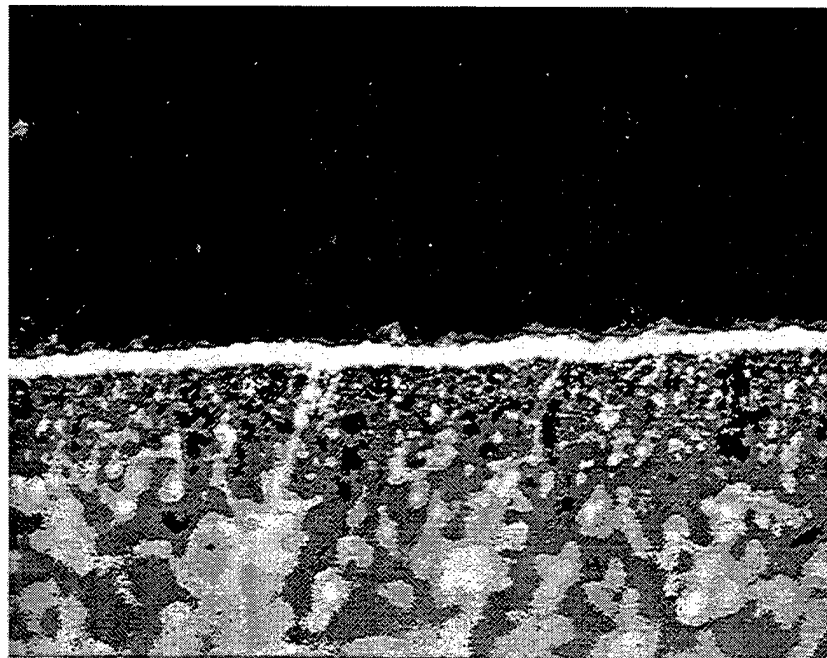
**Figure 83.** Optical Photomicrograph of TDC Layer on Outer Diameter of Outer Ring, 100  $\mu\text{m}$  Thick.  
*Met specification.*

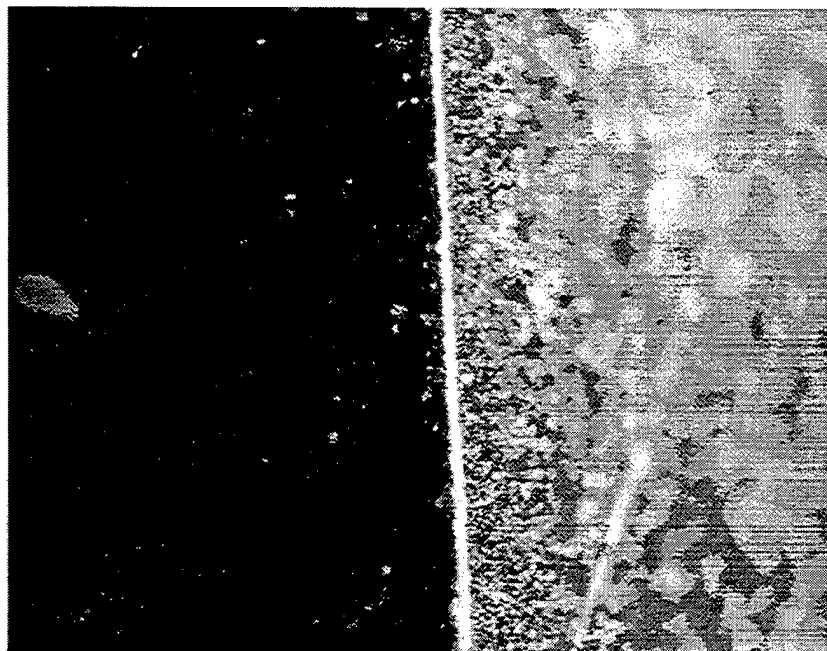
**Figure 84.** Optical Photomicrograph of TDC Layer on Face of Outer Ring, 60  $\mu\text{m}$  Thick.  
*Met specification.*
